AquaServe Management Ltd

Appendix 5

Update on report following the Site Visit on 3rd October 2024

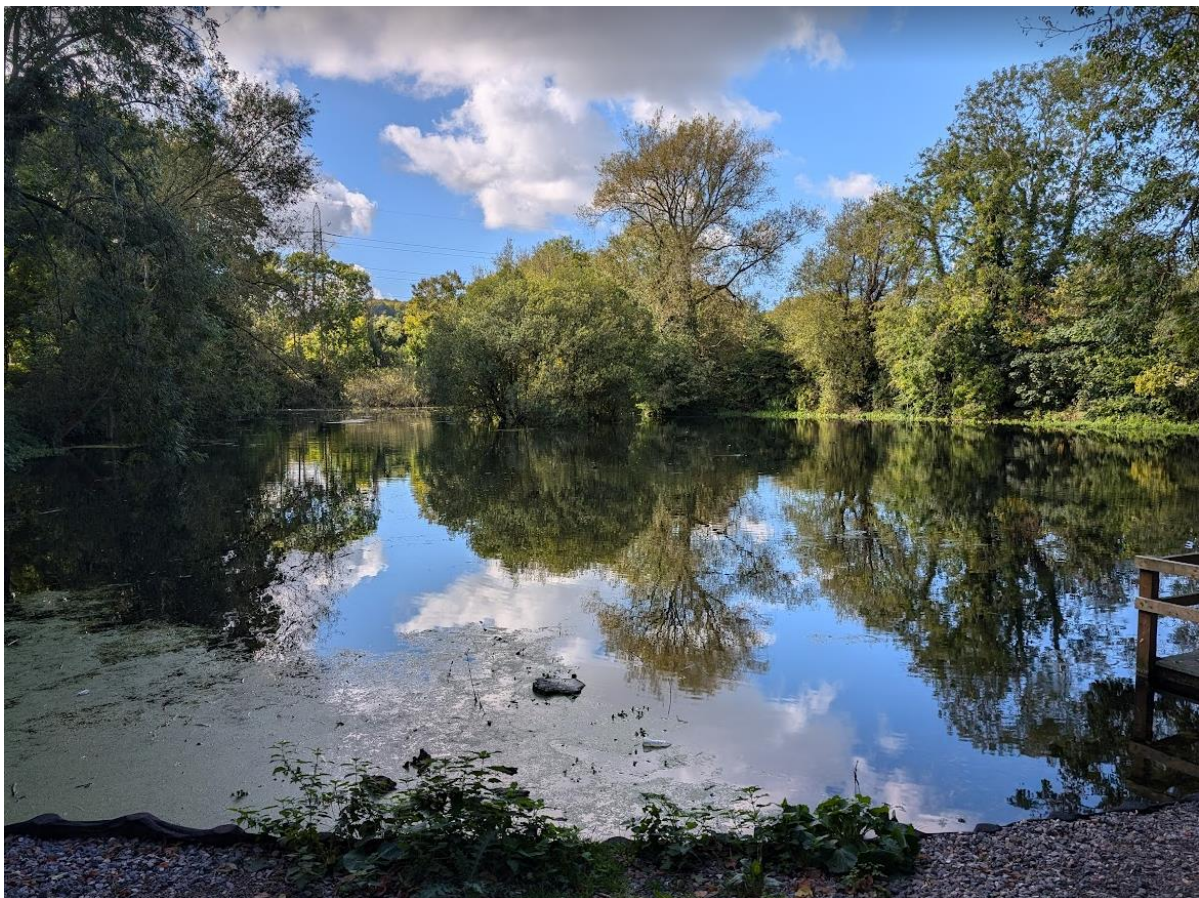
Hampden Pond, October 2024

Water levels were noted to be above the datum point, with water freely discharging from the outlet. No water was entering from the culvert, nor was there evidence of recent recharge from this source. This suggests that water reception is primarily from the aquifer, which appears to be supplying excess water that will assist in flushing excess nutrients from the system.

The pond was filled to the extent that water was actively discharging through the outlet culvert. Site staff confirmed that water levels have remained stable throughout the year, and the pond has maintained a full level since late 2023.

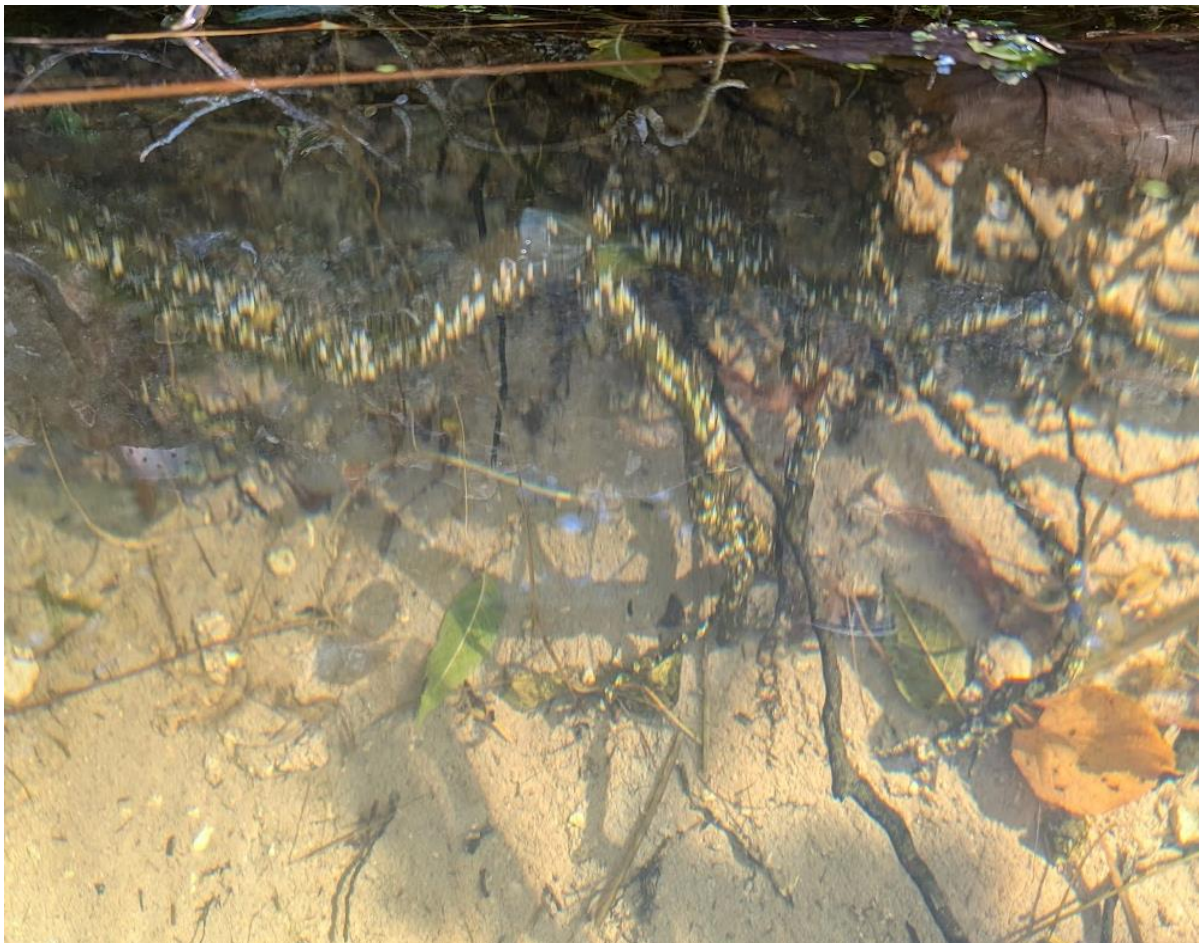
Although no formal testing was conducted, water quality appeared to be good. Clarity was particularly high, with visibility exceeding 600mm in the marginal areas and likely greater in deeper sections of the pond.

Water clarity was excellent

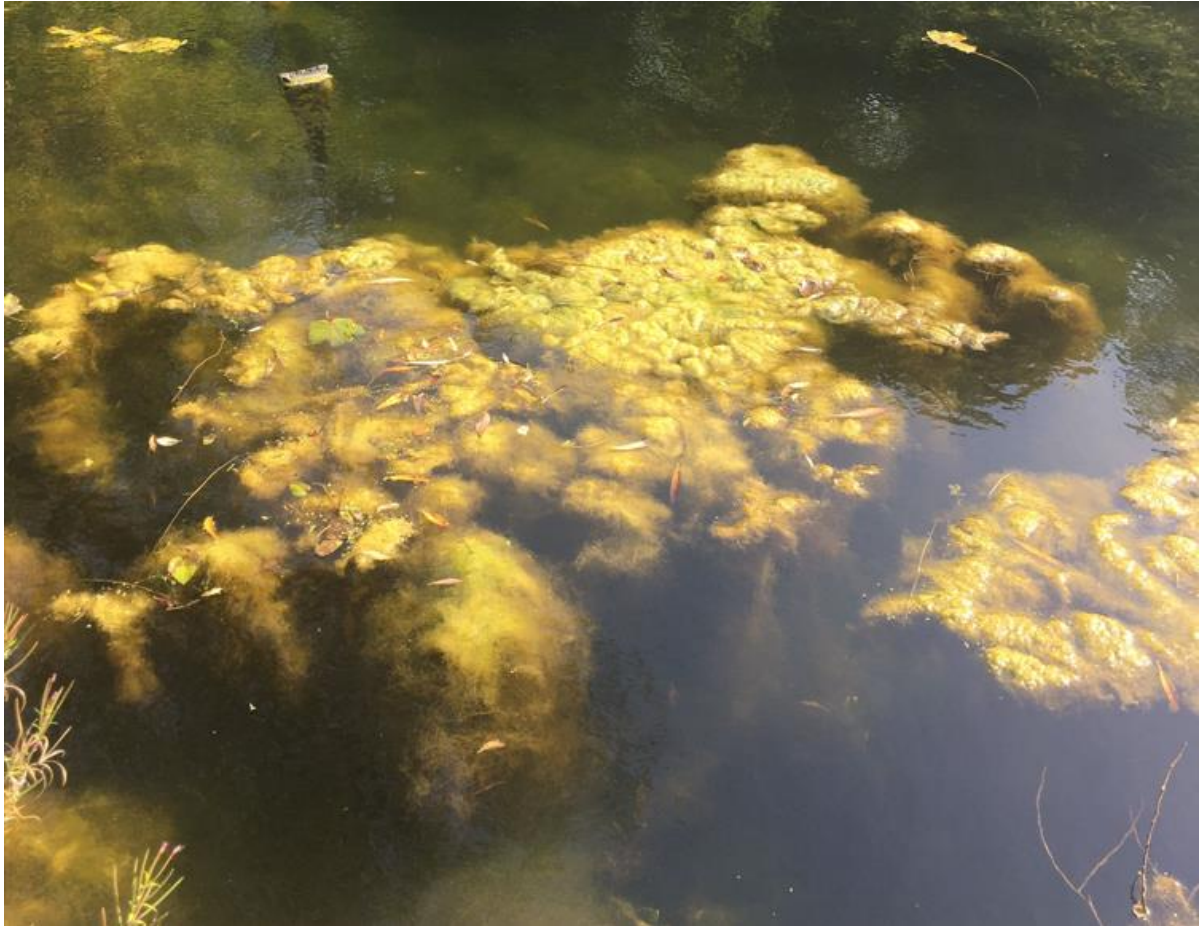
While the water exhibited a slight green tinge due to algae, the clarity remained excellent, surpassing that of comparable ponds. Reports of blue-green algae earlier in the season (September) were noted; however, photographs indicated the presence of Duckweed (*Lemna* spp.) and a filamentous 'Blanketweed' alga, likely *Cladophora* spp. Although *Cladophora* can be unsightly, it is a harmless species. Both species have since diminished, likely in response to seasonal changes in water nutrient levels and temperature.

Cladophora is a common and harmless algae species

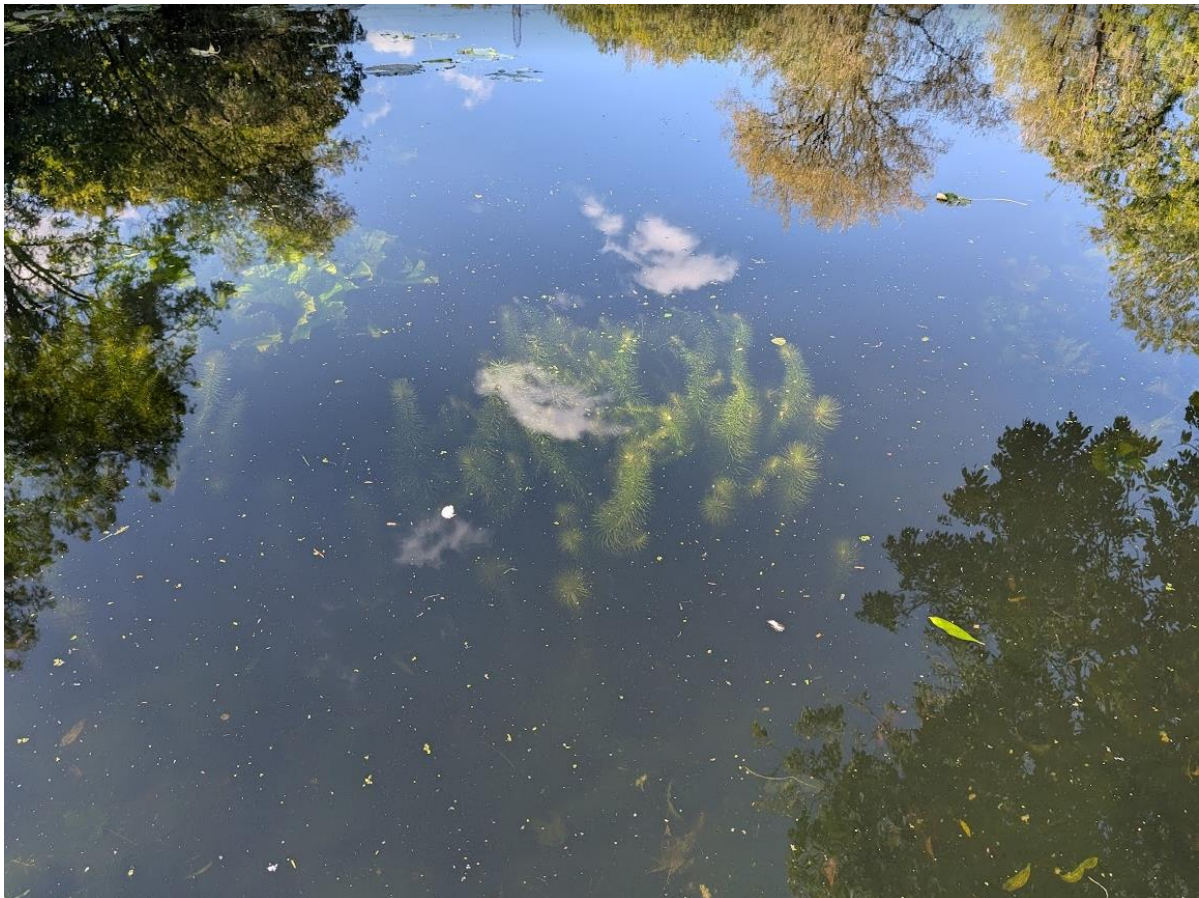
Rigid Hornwort (*Ceratophyllum demersum*)

Rigid Hornwort (*Ceratophyllum demersum*): Rigid hornwort, a free-floating aquatic plant, is highly beneficial for pond ecosystems. Growing quickly, it acts as a natural filter by absorbing excess nutrients like nitrates and phosphates, which helps prevent unwanted algae growth and maintains water clarity. This plant also releases allelopathic chemicals that inhibit algae, fostering a balanced aquatic environment. Its dense, feathery foliage serves as a habitat and breeding ground for fish and invertebrates, promoting biodiversity. Since it does not anchor to the pond's sediment, hornwort can thrive at various depths without disturbing the pond's layers. This species was observed forming several healthy, moderate-sized clumps in the northeast quadrant of the pond, establishing distinct patches in excellent condition.

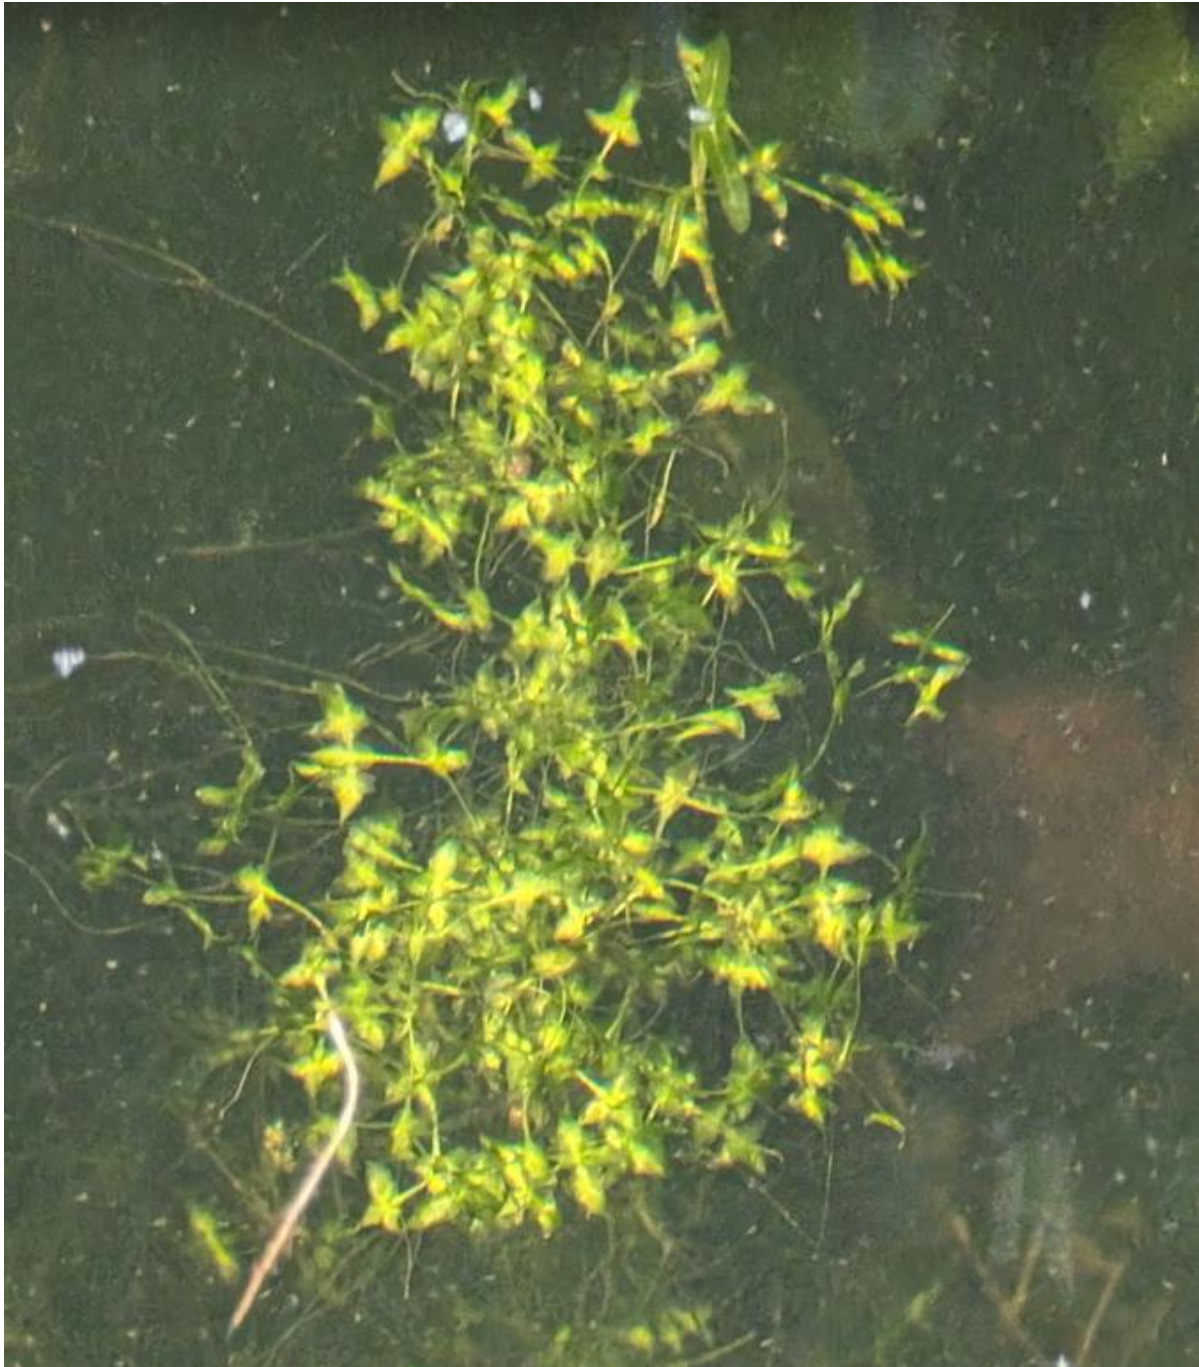
Ivy-Leaf Duckweed (*Lemna trisulca*)

Ivy-Leaf Duckweed (*Lemna trisulca*): Ivy-leaf duckweed, a small floating plant, offers numerous benefits to pond ecosystems. Its ivy-shaped leaves form a dense surface mat, providing shade that limits algae growth by reducing sunlight penetration, maintaining cooler water temperatures, and promoting better water quality. This plant absorbs nitrogen and phosphorus, preventing nutrient overload and the risk of algal blooms. Additionally, ivy-leaf duckweed creates sheltered habitats for fish and small amphibians, and serves as a food source for wildlife, contributing to a balanced ecosystem. One small patch of ivy-leaf duckweed was identified in the northeast quarter of the pond, helping diversify the plant community.

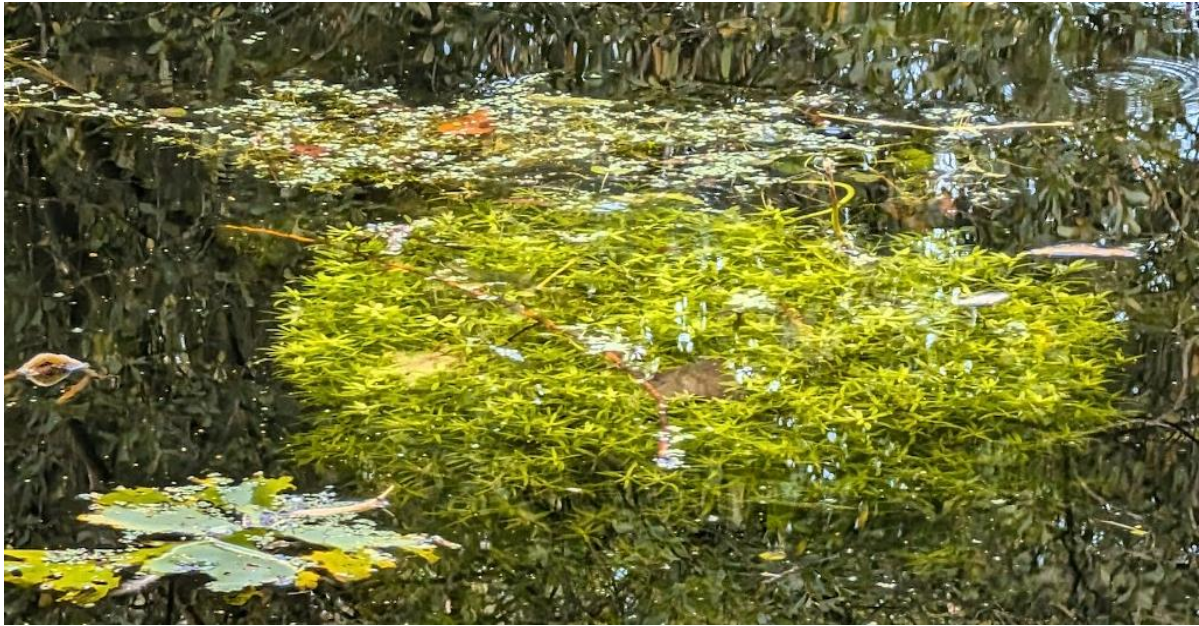
: Water Starwort (*Callitriche* spp.)

Water Starwort (*Callitriche spp.*): Known for its delicate, star-shaped floating leaves, water starwort provides essential habitat for invertebrates and supports pond oxygenation, benefiting fish and other aquatic life. This plant absorbs excess nutrients, helping control algae and enhance water clarity. Its spreading habit and subtle visual appeal make it ideal for naturalistic ponds. A small patch of water starwort was observed in the southwest corner of the pond, thriving in an area that had previously been dominated by lilies and now benefits from increased sunlight due to nearby tree crown lifting.

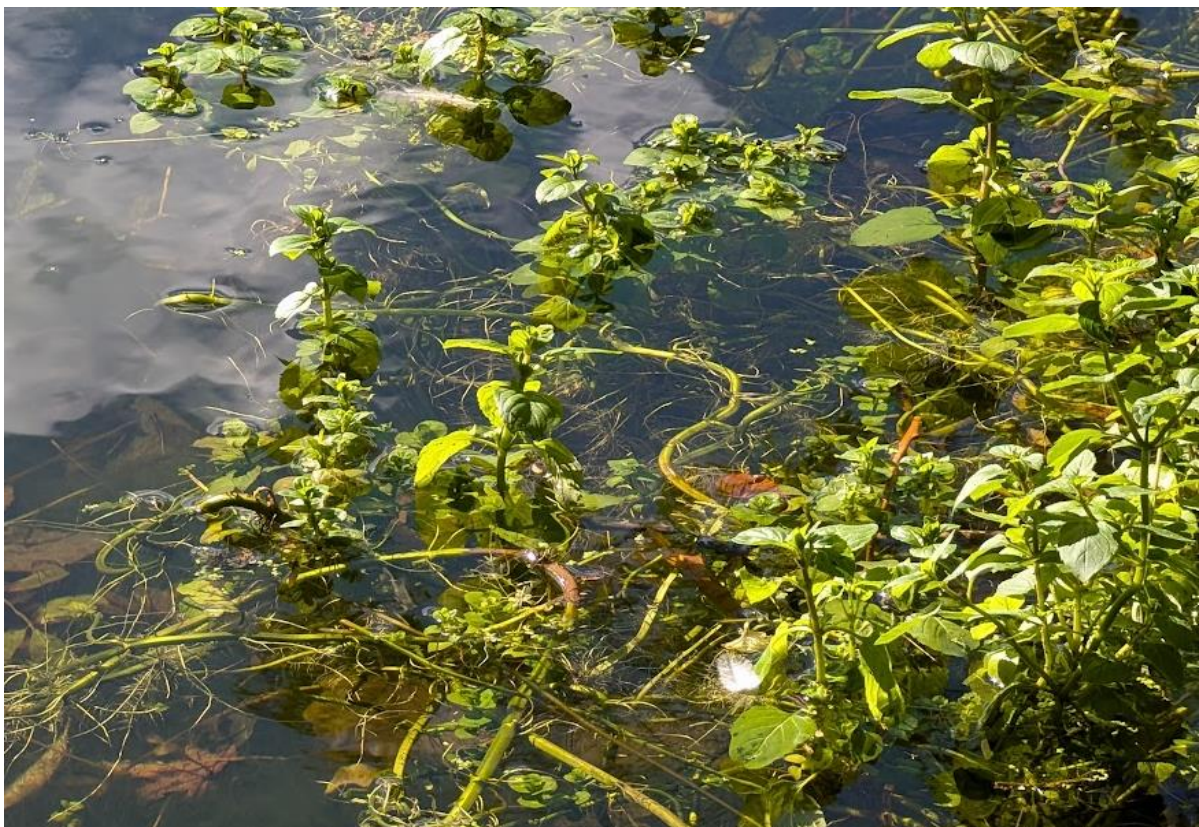
Brooklime (*Veronica beccabunga*)

Brooklime (*Veronica beccabunga*): Brooklime, with its bright green leaves and small blue flowers, naturally thrives along pond edges, providing essential cover for aquatic insects, larvae, and tadpoles. This hardy native plant absorbs excess nutrients, preventing algal blooms and enhancing water quality. Its fibrous roots help stabilise pond edges, reducing erosion. The plant's spread on the pond's northern bank extends approximately 12 meters from the east edge, covering about 3 meters into the pond. This area was intentionally designated as a heavily vegetated zone, with brooklime establishing successfully, likely aided by additional sunlight from tree removal.

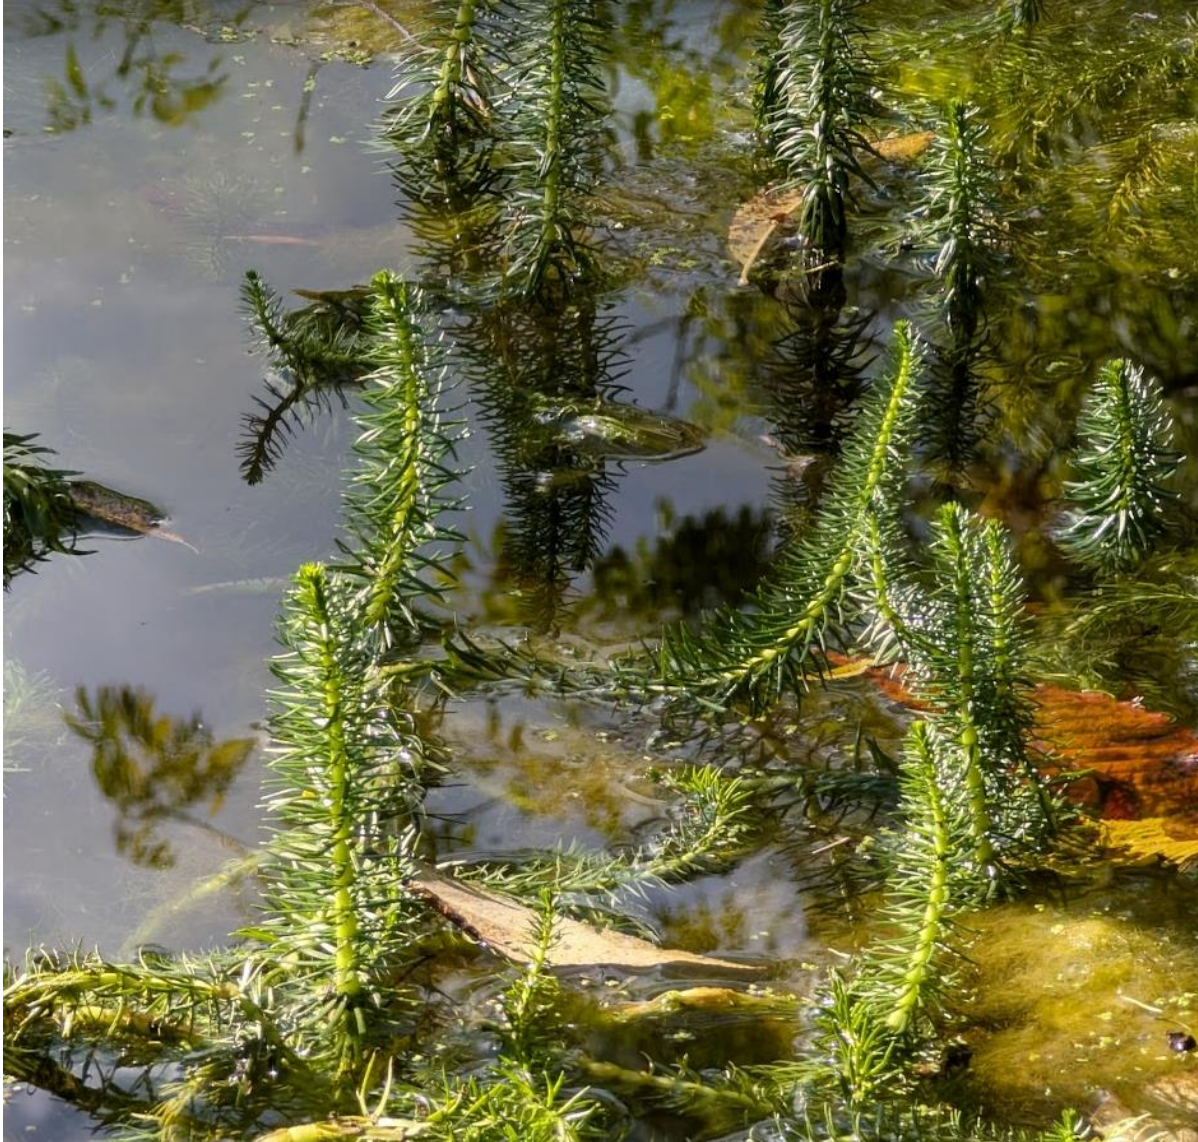
Mare's Tail (*Hippuris vulgaris*)

Mare's Tail (*Hippuris vulgaris*): Recognisable by its whorls of fine, conifer-like leaves, mare's tail thrives in wet conditions, stabilising pond edges with its dense roots. This plant provides shelter for small aquatic creatures and absorbs excess nutrients, reducing algae and supporting a balanced ecosystem. Two distinct patches of mare's tail were observed on the north bank, west of the peninsula, both located in areas formerly dominated by lilies. This successful establishment contributes structural diversity and adds visual interest to the pond.

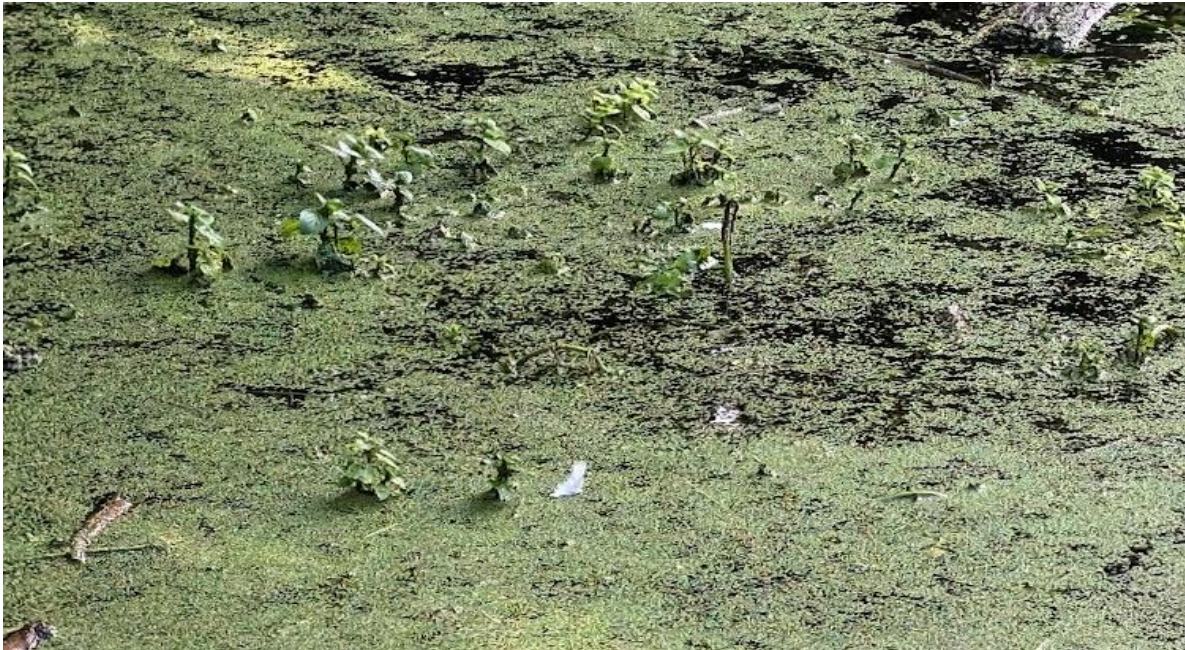
Water Mint (*Mentha aquatica*): Water mint, a fragrant plant with lilac flowers, attracts pollinators like bees and butterflies, increasing biodiversity around the pond. It provides habitat for small fish, frogs, and beneficial insects, while its dense root system helps stabilise pond edges and reduce sedimentation. By absorbing excess nutrients, water mint contributes to water clarity and limits algae growth. Patches of water mint were observed along the eastern and southeastern banks and around the peninsula, mostly in areas previously dominated by lilies. Its spread brings aesthetic and ecological benefits to the pond.

Water Mint (*Mentha aquatica*) surrounded by *Lemna* SP

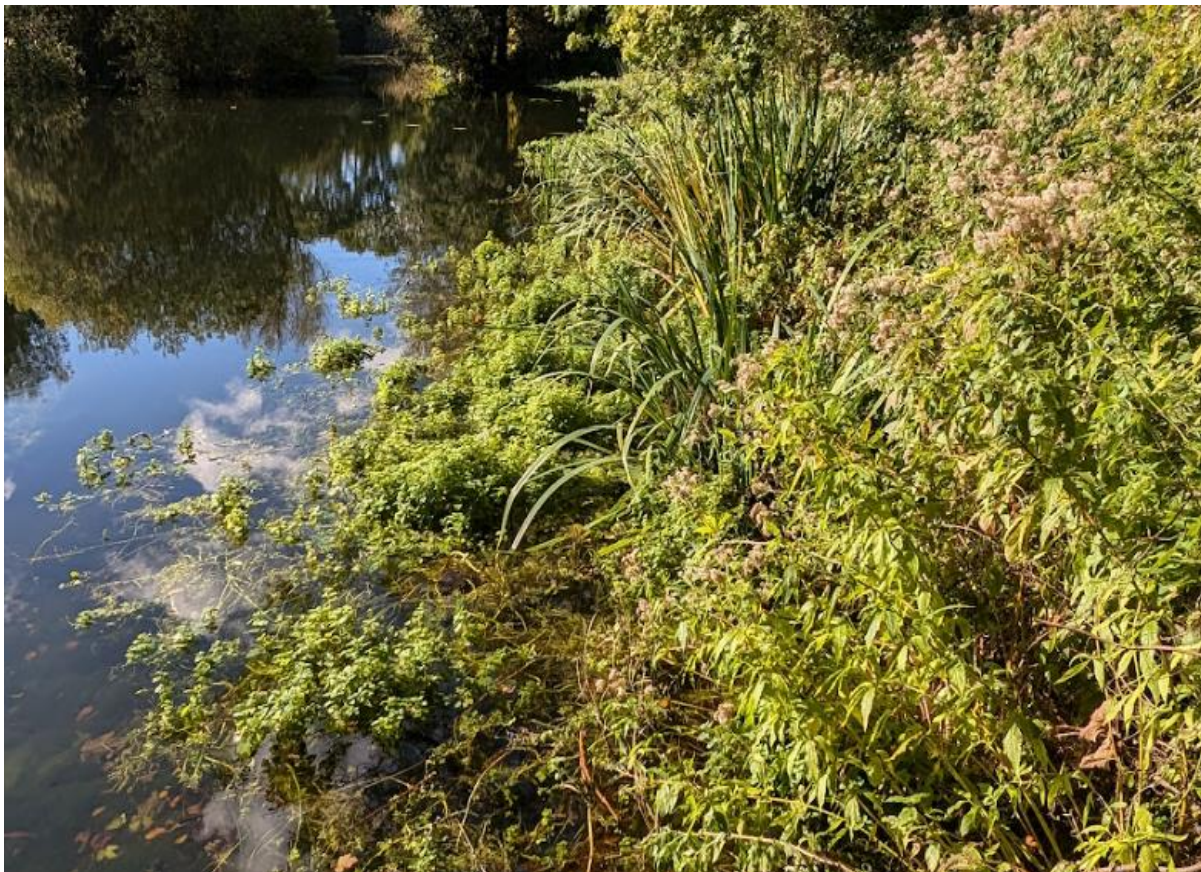
Pendulous Sedge (*Carex pendula*)

Pendulous Sedge (*Carex pendula*): This robust, arching sedge is well-suited for damp, shaded pond edges. Its extensive root system stabilises banks, minimising erosion, while it absorbs excess nutrients that help prevent algae growth and improve water clarity. Pendulous sedge provides shelter for pond wildlife and adds visual appeal with its tall, flowing form. This plant was observed in large patches along the northern bank, similar in location to the brooklime, with smaller clusters spread throughout the pond's edges, including the southeast corner where bank restoration was completed.
